IMPACT DAMAGE ON TITANIUM LEADING EDGES FROM
SMALL HARD OBJECTS

University of Dayton Research Institute
300 College Park Avenue
Dayton, Ohio 45469

TECHNICAL REPORT AFML-TR-78-173

Interim Report for the period July 1976 to October 1977

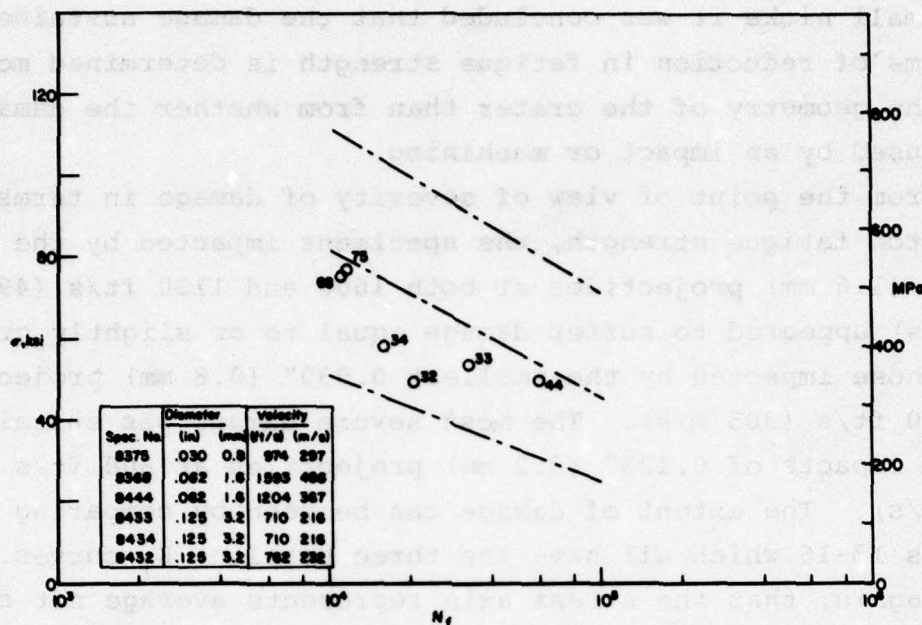
Figure 17. Fatigue data for several shots showing different types of damage.

To further compare the extent of damage in the various specimens, typical shots were chosen from the four batches of tests to represent various degrees and sizes of damage. The six shots chosen are replotted in Figure 17; the photographs showing the corresponding damage before fatigue testing are shown in Figure 18. The test conditions are summarized in Figure 17. Tests 8375, 8368, and 8444 appear to have similar amounts of damage in terms of fatigue life as can be seen in Figure 17 by noting the location of those points with respect to the constant K_T lines. Examination of the photographs in Figure 18 shows that all three shots have the same type of damage, namely a semicircle removed from the leading edge. Note that all three damage sites are geometrically similar, Shot 8375 being approximately one-third the size of the other two. Shots 8433, 8434, and 8432 show apparently increasing damage, respectively, in Figure 17. In Figure 18, it is seen that these three shots correspond to a bulge, material removal, and a bulge with a tear, respectively. It is not obvious whether or not there was any local tearing in Shot 8434. The material removed in

this shot was, in any case, three times the dimensions of that in Shots 8368 and 8444. Shots 8433, 8434, and 8432 all represent impacts of the largest projectile 0.125" (3.22 mm) at approximately 800 ft/s (240 m/s). Note that the worst case of damage, Shot 8432, represented a situation where the material first bulged and then apparently ripped from the extensive local deformation. The fatigue crack initiated at the rip in this case.

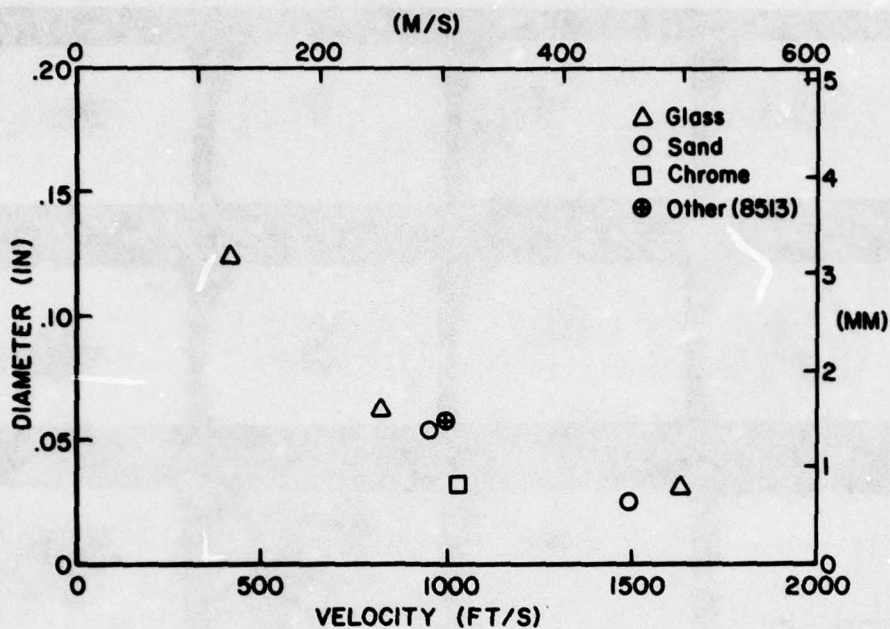
Figure 19. Critical velocity as a function of projectile diameter (0.010" L.E.).

dented the leading edge. One shot, 8513, appeared to cause the beginning of a tear and could be considered a critical velocity condition. This shot was plotted in Figure 19 with the previous data and appeared to follow the established trend, especially considering the scatter and uncertainty. Based on this series of tests, it was concluded that a general trend of decreasing critical velocity with increasing particle size could be established and that this trend seemed to be effected somewhat by geometry (irregularity) and type of material. The biggest problem in establishing this trend was the ability to impact leading edges directly on center with these small particles, although examination of the photographs reveals that the accuracy was surprisingly good and better than originally anticipated. Note, again, that all of the above observations pertained to the case of an 0.010" (0.25 mm) thick leading edge

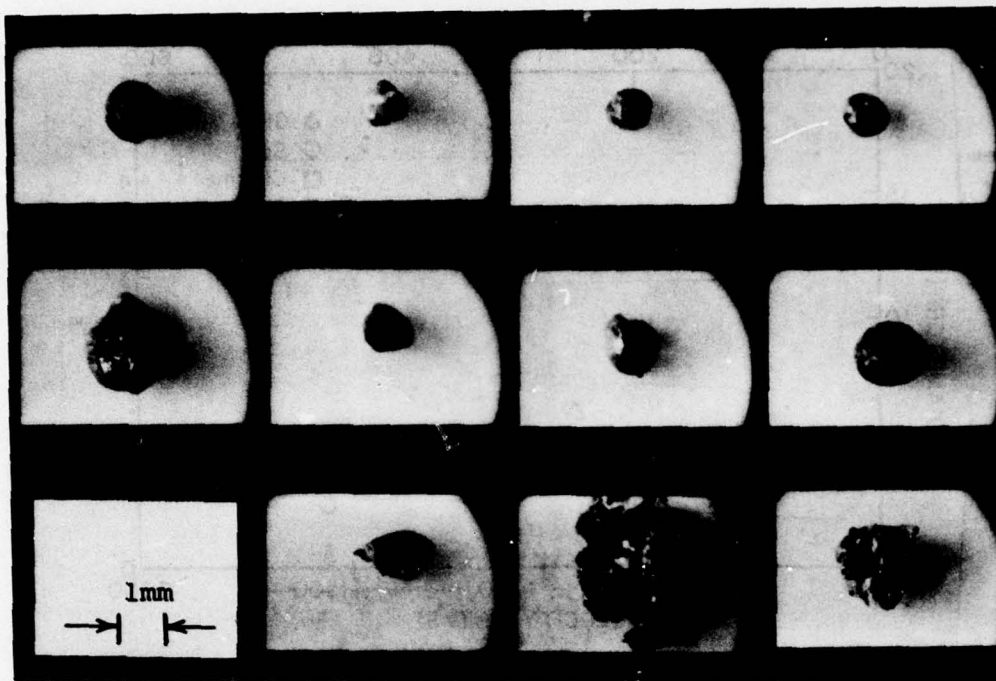
11

such matter. From each bag of debris available, a number of particles were chosen to cover the size range of the debris, not including small particles, dust, and dirt under 0.030" (0.8 mm). The particles were photographed and measured and are designated as Post-Test No. 11, 18, and 23; each particle within the group being numbered. The particles are shown in Figure 20. The test data are summarized in Table 4. Photographs of the damage as seen from the impacted side are presented in Appendix B.

Figure 20. Photographs of particles from Post-Test No. 11, 18, and 23 debris.

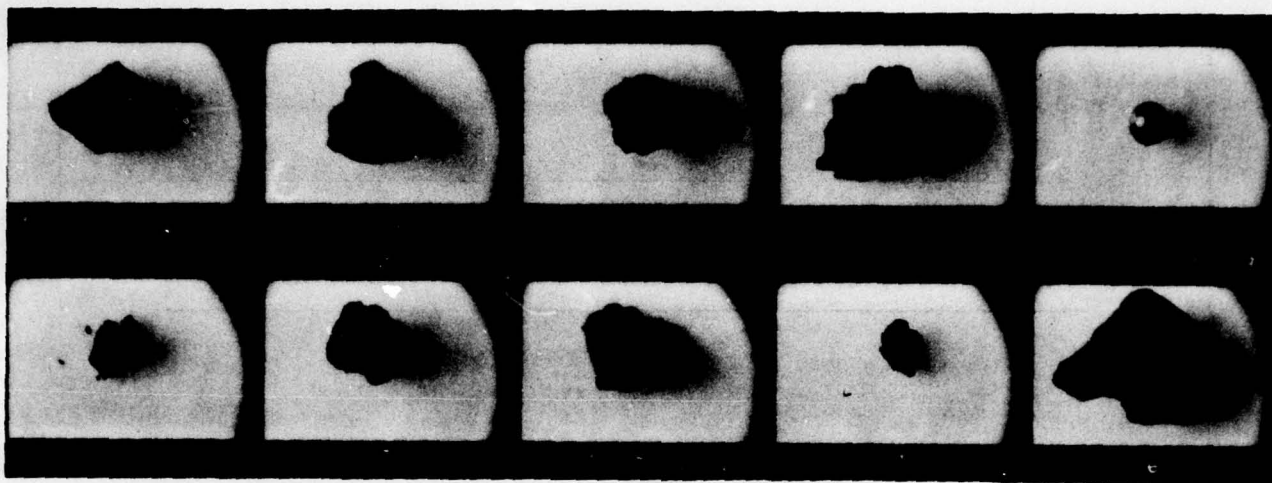
Figure 20 (Cont'd). Photographs of particles from Post-Test No. 11, 18, and 23 debris.

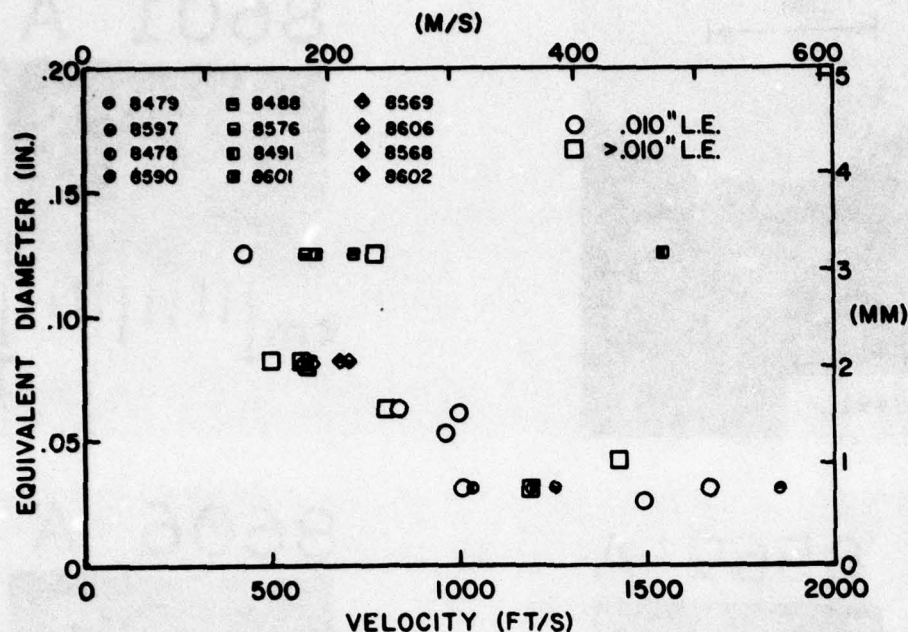
Figure 24. Critical velocity for several select shots.

To illustrate certain features of the damage, and for reference purposes, the data of Figures 19 and 22 were replotted in Figure 24. The open triangles represent the points from shots on 0.010" (0.25 mm) thick leading edges. The solid triangles represent the points from shots on thicker leading edge configurations, the projectile diameter being normalized as explained above. The remaining points are identified individually and are not, in general, meant to represent the critical velocity. They are plotted to illustrate their location with respect to the critical velocity curve as explained in detail below. Several points are shown with two symbols, one representing a critical velocity point to establish the curve and the second symbol to identify the point for discussion purposes.

Shots 8479 and 8597, Figure 23a, are examples of perforation where material removal has occurred. These two points, plotted in Figure 24, come out to the right or along the curve or scatter band representing the critical velocity points. Both

shots represent damage typical of that which occurs above the critical velocity. The slightly more jagged surface of the perforation in Shot 8597, occurring at the lower of the two velocities being compared, indicates that this point is close to critical velocity as can be seen from Figure 24.

Shots 8478 and 8590, Figure 23b, occur at velocities close to one another. The damage in both cases looks similar, although in Shot 8590 the leading edge has started to tear. This was one of the shots characterized as at critical velocity, in Figures 22 and 24. Shot 8478 occurs at a slightly lower velocity and shows a dent without a tear. This would be considered to be slightly below critical velocity and appears as such in Figure 24.

Shots 8488 and 8576, Figure 23c, both show very similar damage involving severe denting but no tearing of the leading edge. The velocities of these shots are close to one another and are considered to be slightly below critical. These points, plotted in Figure 24, fall within or to the left of the scatter

band. Although no tearing of the leading edge occurred, it is felt that these were close to critical velocity because of the extensive bulging and the plot of Figure 24 appears to support this premise.

Shots 8491 and 8601, Figure 23d, are a pair of shots showing very similar damage in the form of complete perforation with material removal. These points would both be expected to fall above the critical velocity. Note, however, the great difference in velocities. Although, as expected, Shot 8491 is well to the right of the critical velocity scatter band in Figure 24, Shot 8601 falls within the band. Shot 8601 is a good example of the variability in damage which can be expected and the difficulty in determining the critical velocity with a great deal of accuracy from a limited number of shots.

Shots 8569 and 8606, Figure 23e, occurred at almost identical velocities and look very similar in type of damage. Both show a crater, indicating complete perforation, although both have rather jagged features along the crater. This indicates that the critical velocity has just been exceeded. The plot of Figure 24 appears to verify this information, the two points falling within or slightly to the right of the critical velocity band.
